Smoke and Dye Testing Summary

High Level Sewershed

Test ID	Test Type	Date Inspected	Company / Super.	Blower MH	Ground Condition	Notification Made?	Total Length
S1028-119	Smoke	10/21/2008	ADS/TM	S0900_015MH	Dry	Yes	1,235.27

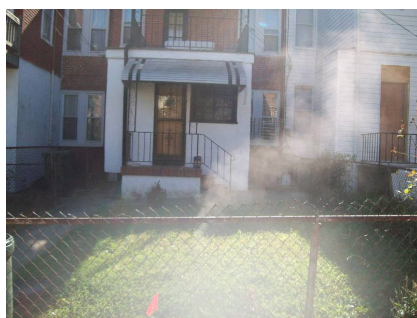
Picture \S1028-119-OB01-P01.jpg

Comments Smoke from cleanout in back yard. 3332 Piedmont Ave.

Comments Back of house, 3332 Piedmont Ave.

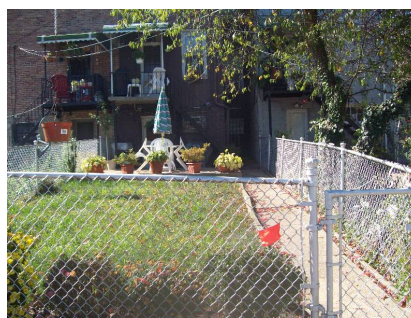
Picture \S1028-119-OB02-P01.jpg

Comments Smoke from cleanout in back yard. 2605 Denison St.

Comments Back of house, 2605 Denison St.

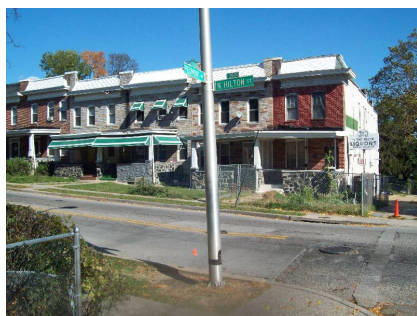
Picture \S1028-119-OB03-P01.jpg

Comments Smoke from catch basin along curb on NW corner of Piedmont Ave & Hilton St

Comments Piedmont Ave & Hilton St looking east

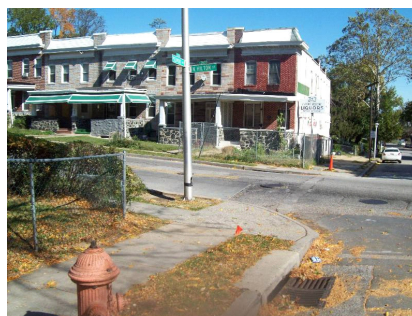
Picture \S1028-119-OB04-P01.jpg

Comments Smoke from catch basin along curb on NW corner of Piedmont Ave & Hilton St

Comments Piedmont Ave & Hilton St looking east

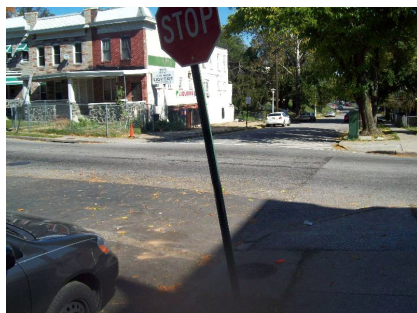
Picture \S1028-119-OB05-P01.jpg

Comments Smoke from catch basin along curb on SW corner of Piedmont Ave & Hilton St

Comments Piedmont Ave & Hilton St looking east

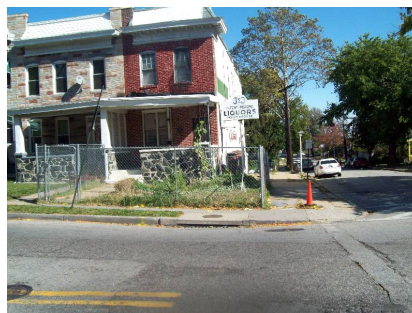
Picture \S1028-119-OB06-P01.jpg

Comments Smoke from catch basin along curb on NE corner of Piedmont Ave & Hilton St

Comments Piedmont Ave & Hilton St, looking east
